Lower Colorado River Multi-Species Conservation Program

Hart Mine Marsh: Annual Report 2010

August 2012

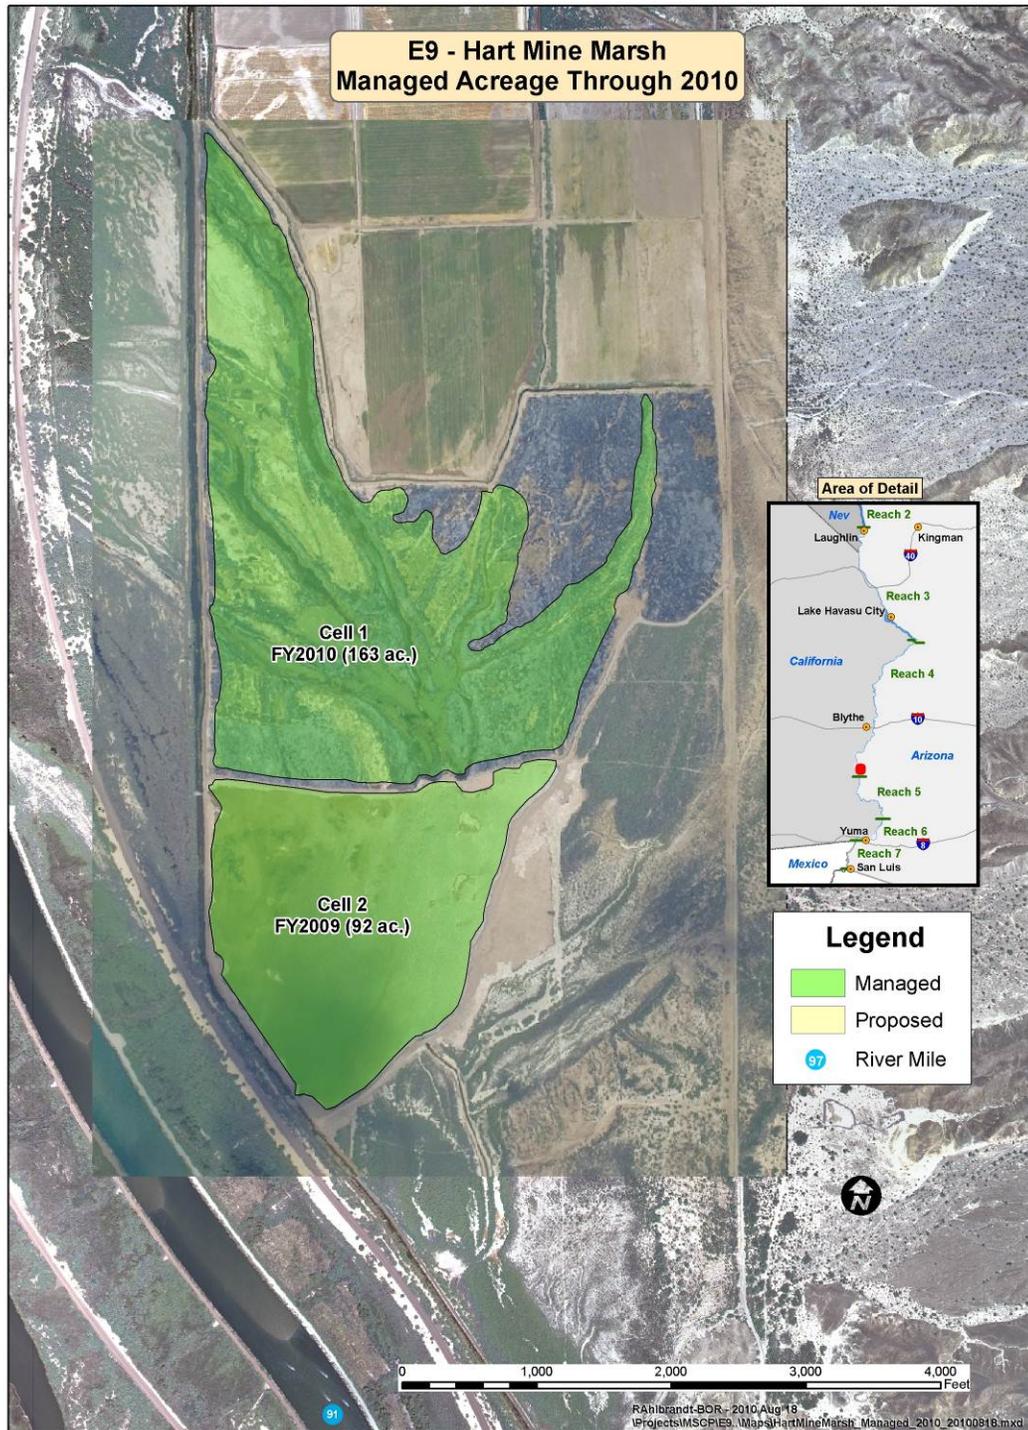
Figure 3. Managed acres of Hart Mine Marsh through 2010.

The HMM consists of approximately 255 acres on CNWR located in Arizona between river miles 90 and 93 (figures 2 and 3). The initial partnership for HMM includes Reclamation and the USFWS.

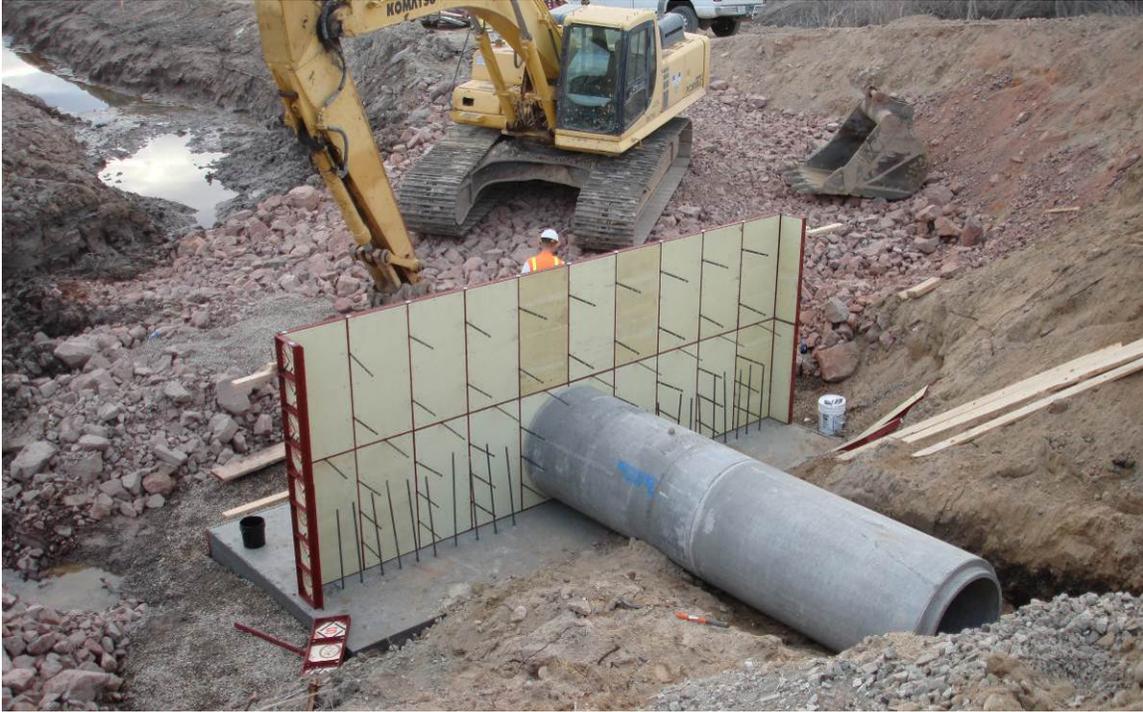
Figure 4. Installation of HMM Colorado River outlet control structure.

While the clearing activities were ongoing in cell 2, a series of seven control structures were installed at the outlet of the marsh, within cell 2, and along the Arnett Ditch (figures 4 and 5). These included two structures to route the discharge water from the marsh, three structures located along the Arnett Ditch to provide inlets/outlets for cells 2 and 3, and two structures placed between cells to allow water to pass from cell 1 (not constructed until FY10) into cell 2 and from cell 2 into cell 3. Cell 3 was incorporated into the marsh complex, but was not cleared or contoured and will be managed by the USFWS. Cell 3 is not part of the LCR MSCP HMM conservation area.

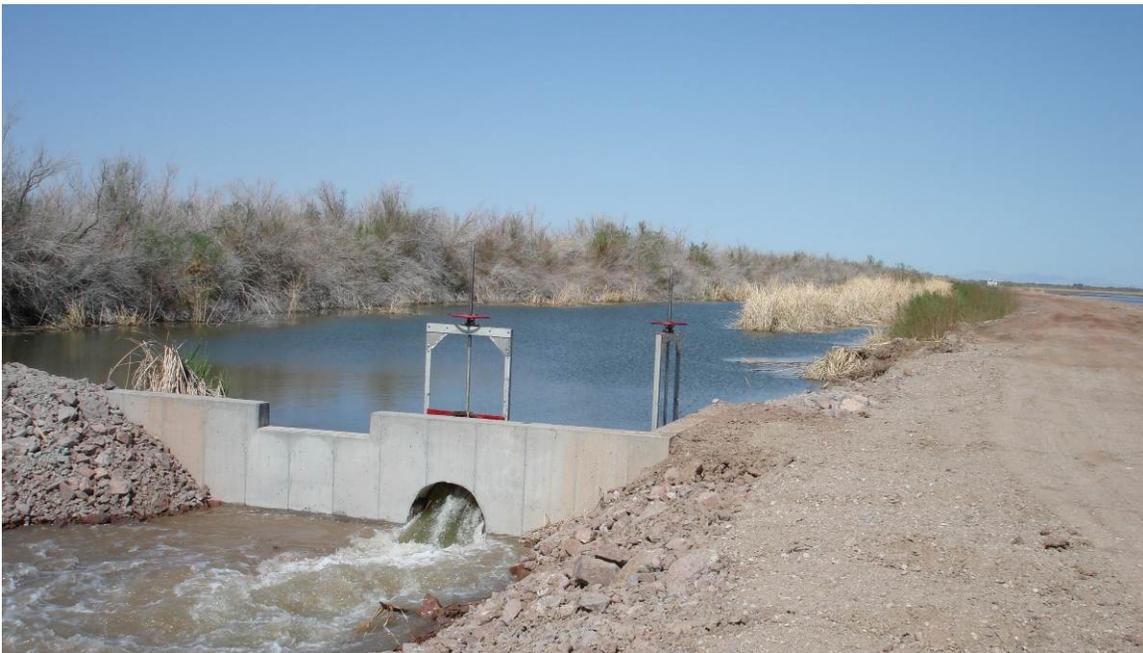
Figure 5. One of the controls structures on the Arnett Ditch used to divert water into HMM, cell 2.

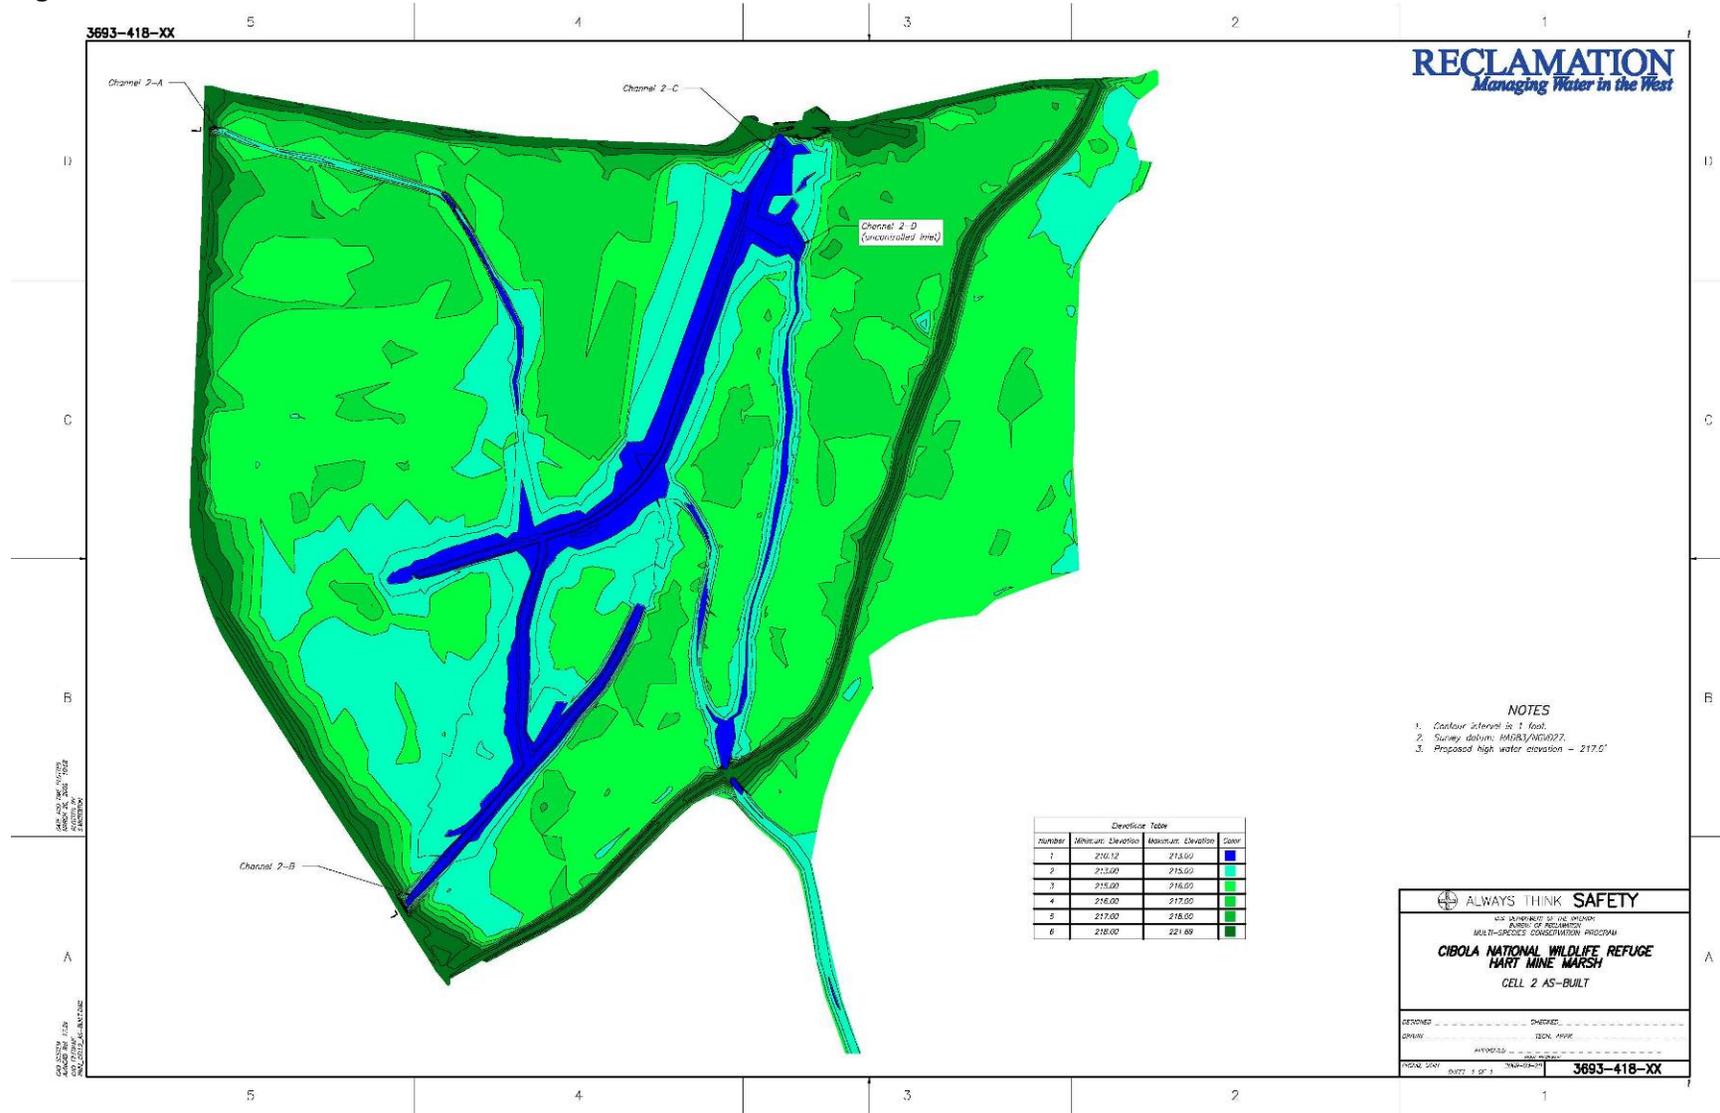
Figure 6. HMM cell 2 asbuilt.

After the areas in cell 2 were cleared, channels were excavated following the existing geomorphology of the site to connect the inlet and outlet structures. These channels were also intended to maintain areas of permanent open water and to provide deeper water continuity for better management of water quality. Channel depths ranged from 213 feet (NGVD27) to 210 feet (Figure 6). The excavated material from the channels was used to create the dikes confining cell 2 or was incorporated in the contouring of the cell as dictated in the grading plan. Cell 2, approximately 92 acres, was filled in mid-March 2009 and held at approximately 216.5 feet through August, 2009 (Figure 7).

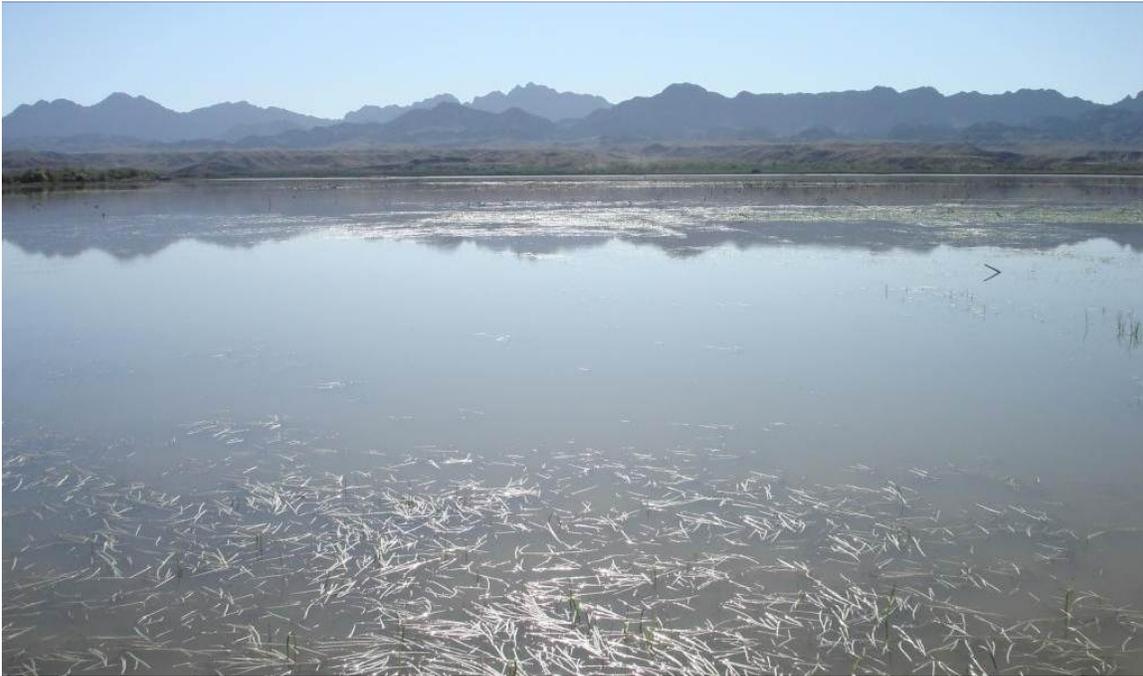
Figure 7. Cell 2 in June 2009 filled to elevation 216.5' after completion of construction. New cattail growth is pictured in the foreground.

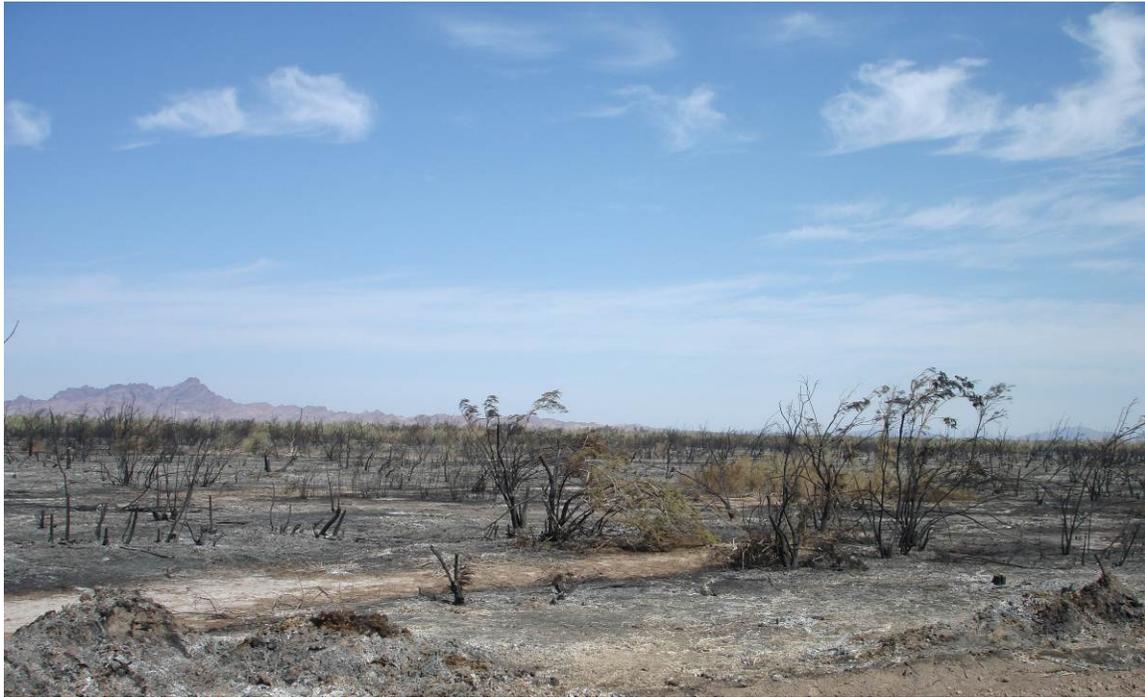
Figure 8. Part of cell 1 after the recent controlled burn at HMM in June 2009.

In June 2009, the USFWS performed a controlled burn on the area north of cell 2 at HMM (Figure 8). The intent was to facilitate clearing for the next phase of construction at HMM by decreasing the volume of woody debris that would have to be grubbed and buried on site. The burn was successful and also improved visibility in areas for heavy equipment operators.

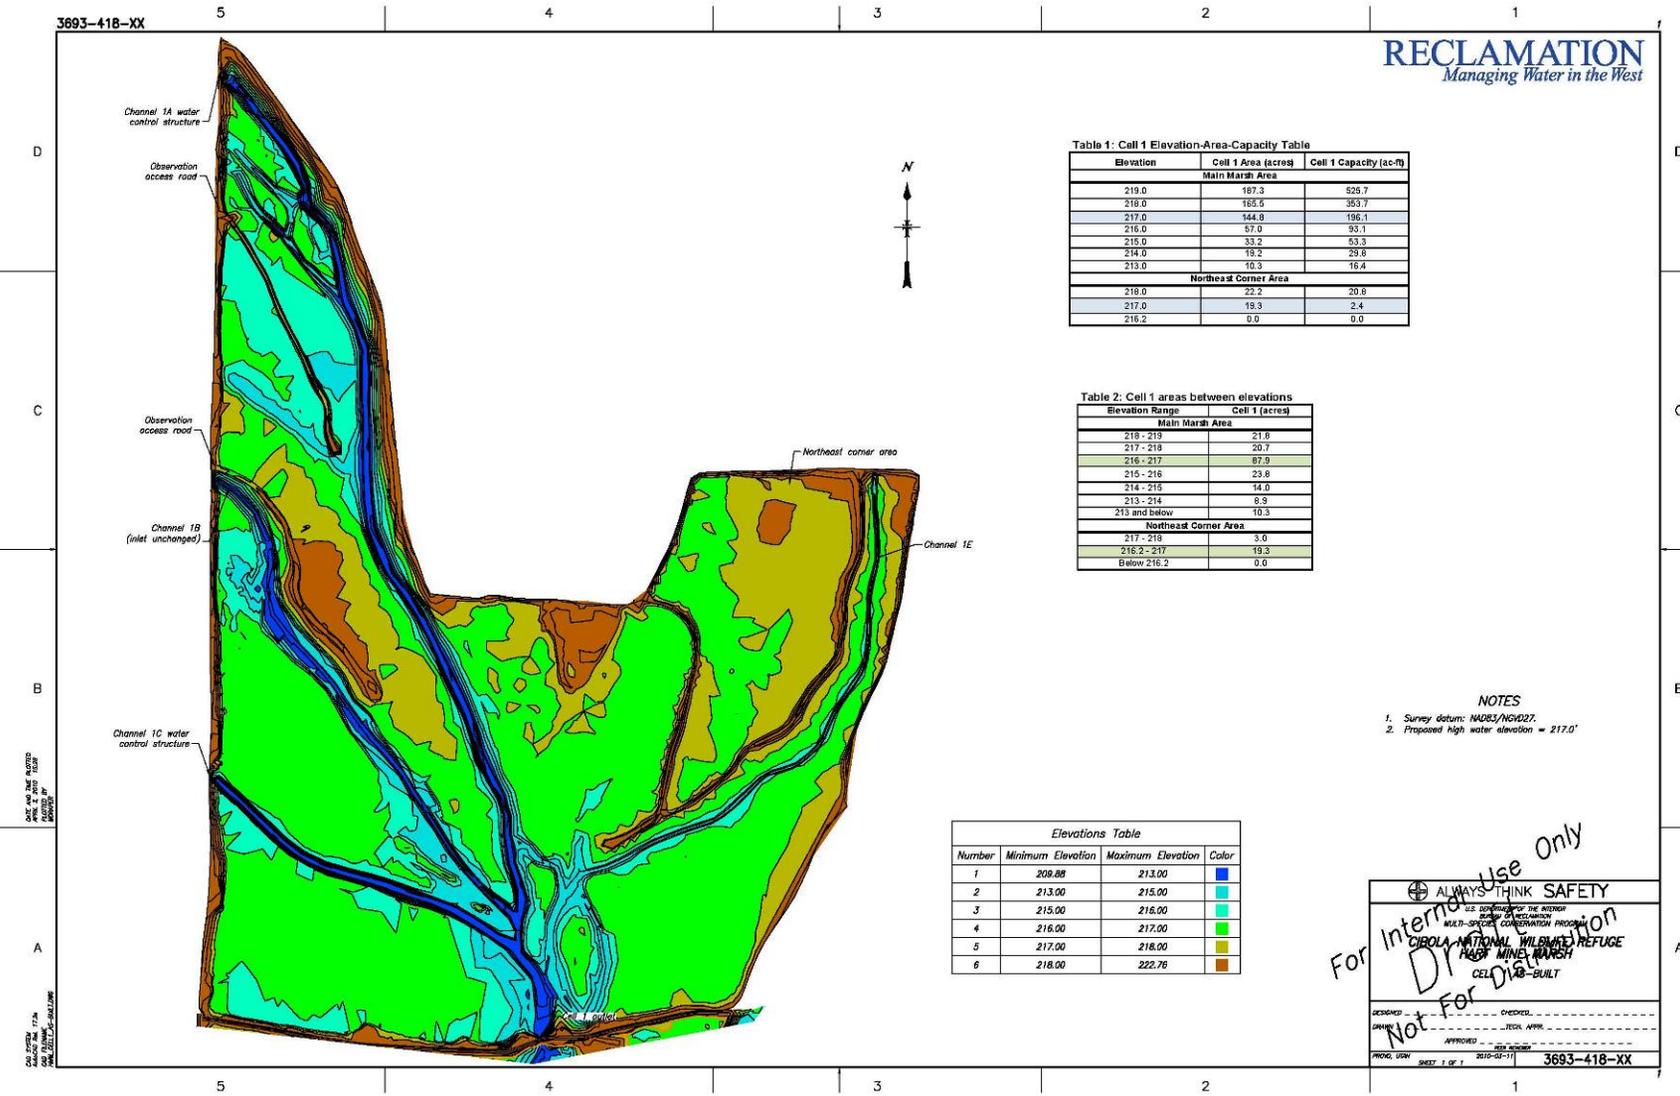
Figure 9. HMM cell 1 asbuilt.

Cell 1 was constructed from October 1, 2009 through March 1, 2010. This included the removal of primarily saltcedar and other vegetation from the design footprint of the phase. The controlled burn that was conducted in the summer by USFWS prior to this construction phase facilitated grubbing and clearing. Construction crews were able to clear over 200 acres. During this clearing effort, the construction crews were able to leave a number of standing dead trees to serve as roosting sites for birds. Similar to the procedures in the construction of cell 2, channels were excavated and cleared areas were contoured. Excavated materials were used to construct the confining dikes/perimeter roads for the cell or balanced on site during contouring (Figure 9). Two additional control structures were installed on the Arnett Ditch adjacent to cell 1 to provide an inlet and outlet for the cell. The supply culvert that directs pumped water into the Arnett Ditch was also upgraded to a concrete box culvert to increase its capacity. Cell 1, approximately 163 acres, was filled in early March 2010 (Figure 10). An additional cell of approximately 23 acres, located adjacent to the NE corner of cell 1, was created to be managed by the USFWS and is not part of the HMM conservation area.

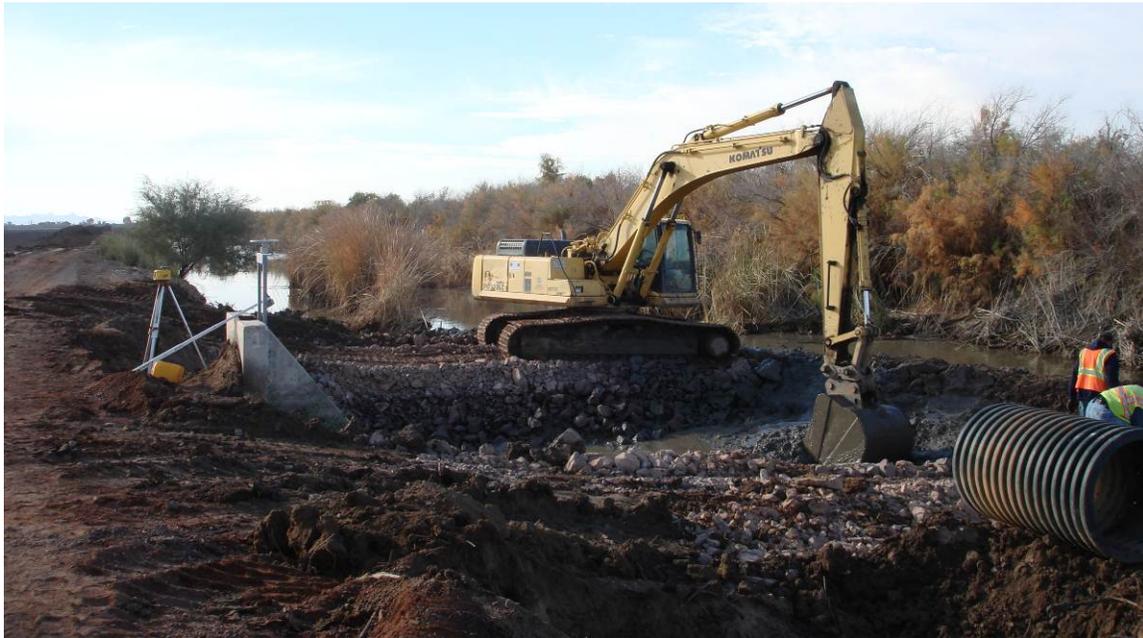
Figure 10. Construction of a control structure along the Arnett Ditch for cell 1 at HMM, January, 2010.

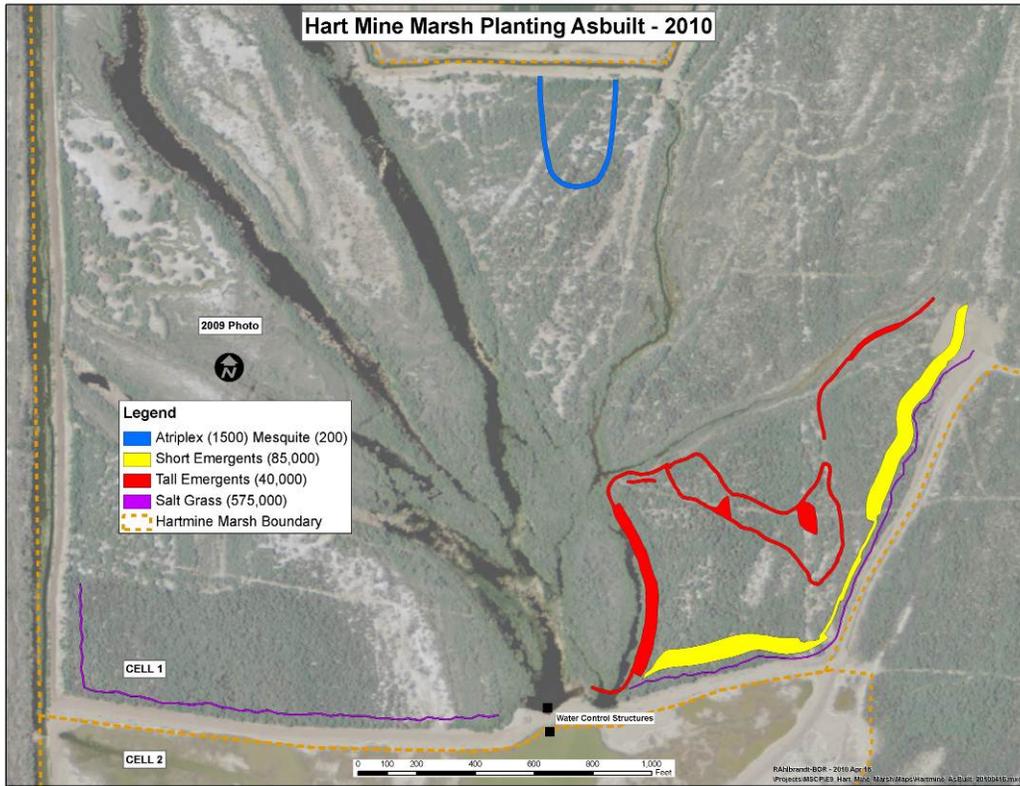
Figure 11. Hart Mine Marsh Planting asbuilt showing the location, species, and number planted at HMM in 2010.

Cell 1 was drawn down approximately 2 feet, 10 days prior to planting to enable crews to access areas that would have the proper range of water depths for the selected marsh plants. The emergent marsh species were planted on the eastern side of cell 1 (Figure 11).

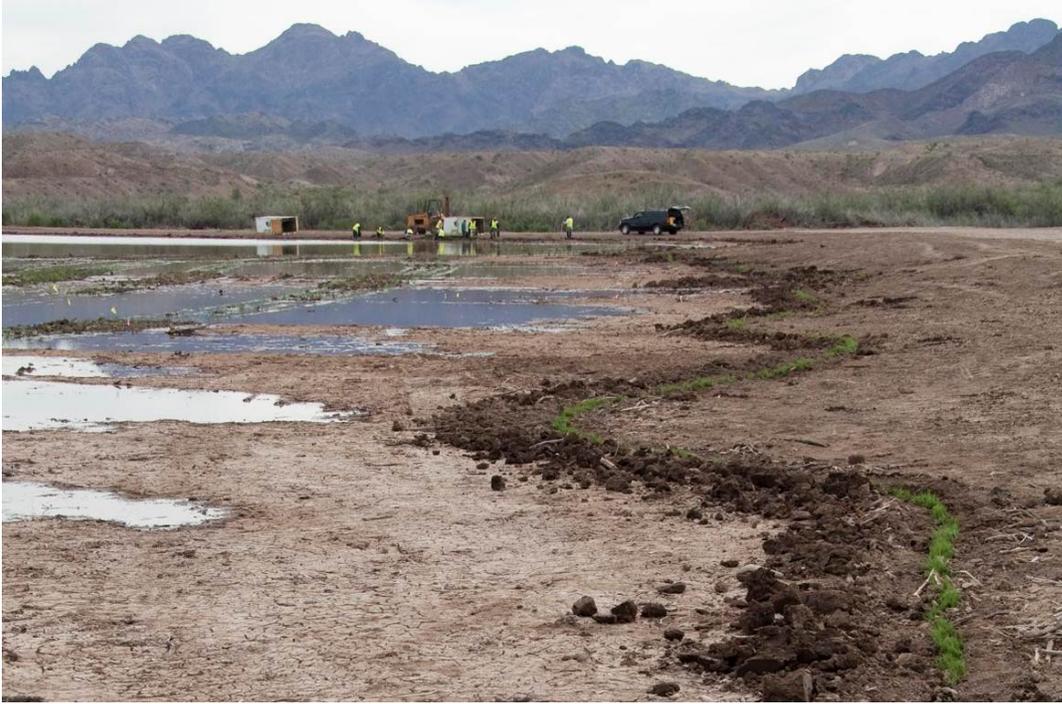
Figure 12. Saltgrass being hand planted around cell 1 at HMM in March 2010. Recent planted marsh species are also present in the background.

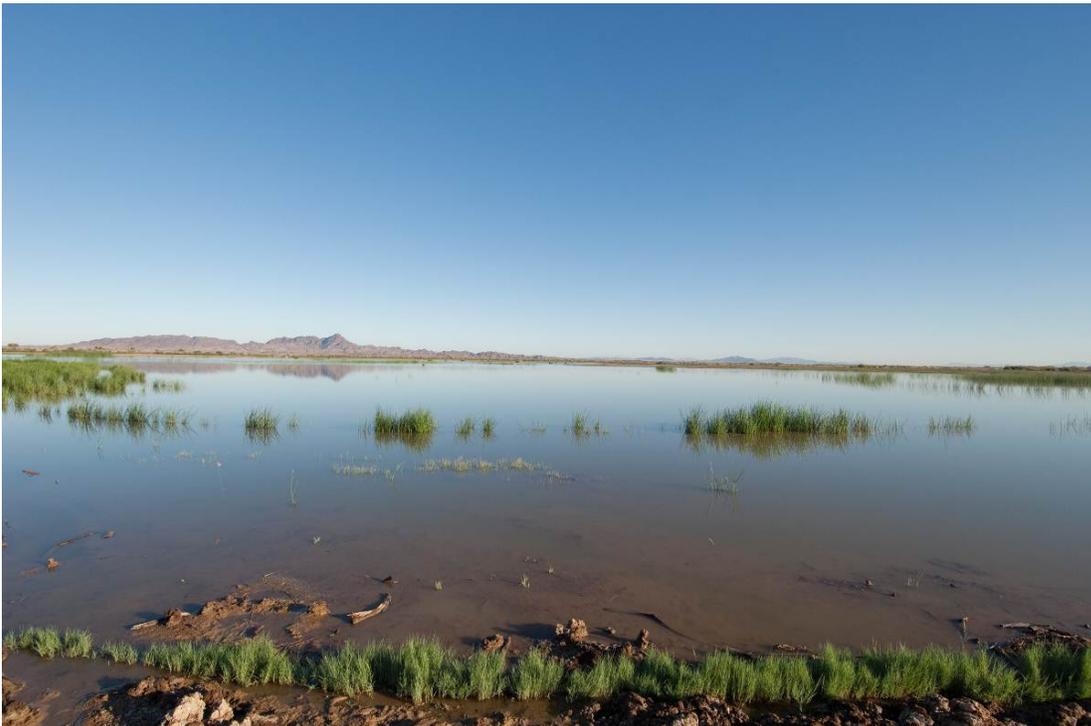
Figure 13. Photo point 9: planted saltgrass (foreground) and marsh species (background), June 2010.

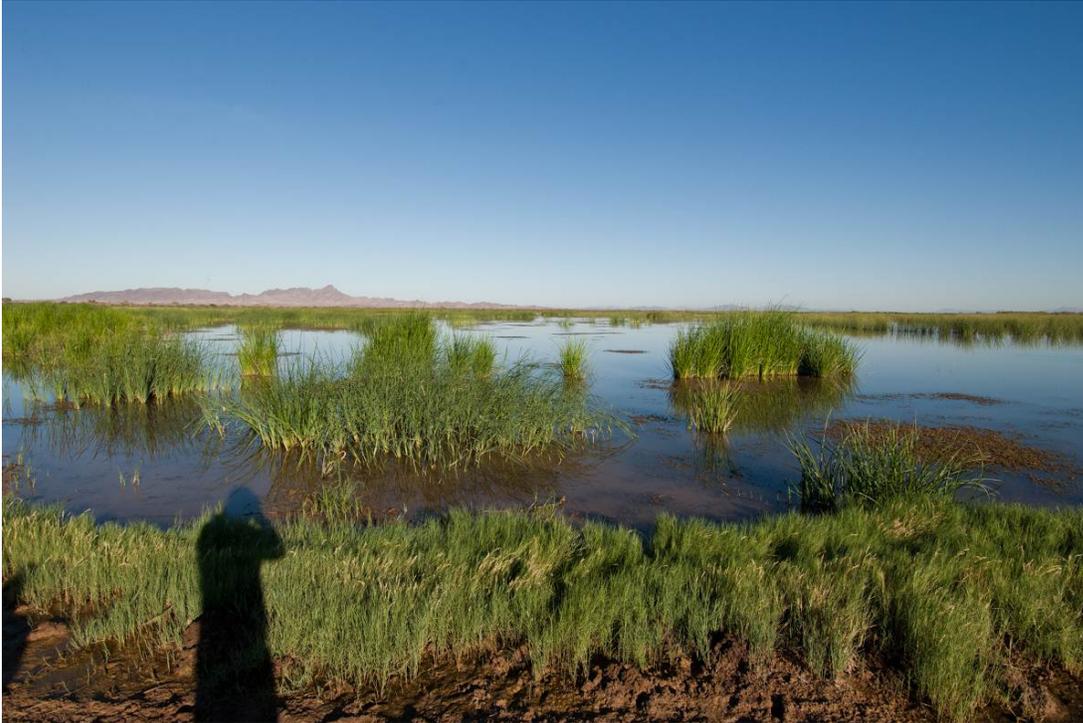
Figure 14. Photo point 9: planted saltgrass (foreground) and marsh species (background), September 2010.
