# Lower Colorado River Multi-Species Conservation Program

## Big Bend Conservation Area

## 2016 Annual Report

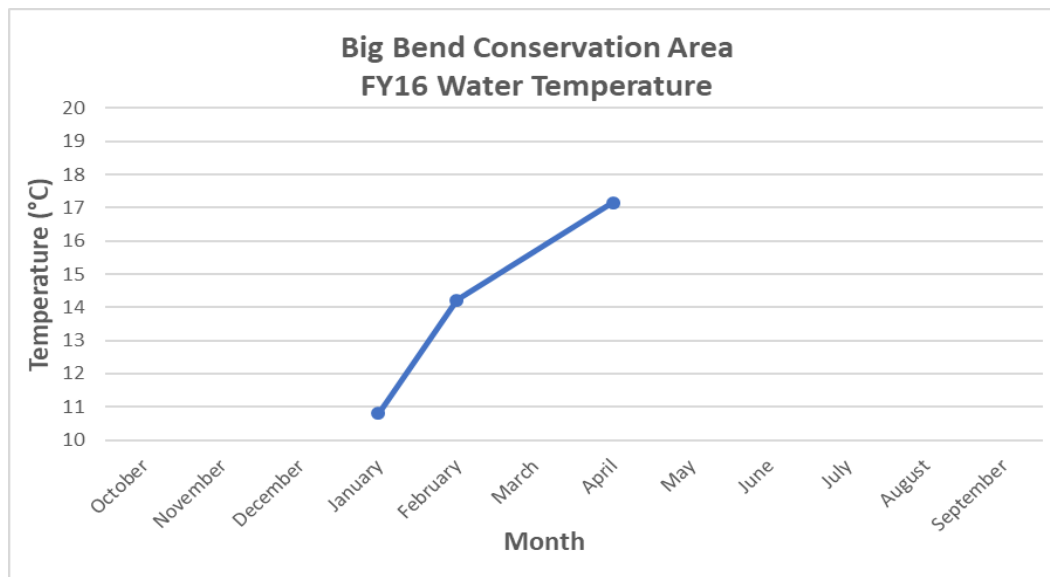
Figure 3.—BBCA water temperature, FY16.

Water quality was recorded at a single location in the backwater during selected monitoring trips. A multi-parameter probe was used to record water temperature in degrees Celsius (°C), dissolved oxygen in milligrams per liter (mg/L), specific conductivity in microsiemens per centimeter (µS/cm), and pH. Due to its hydrological connection to the river, this backwater maintained excellent water quality throughout the year. Water temperature, dissolved oxygen, specific conductivity, and pH all remained within the known thresholds for native fishes throughout FY16. Water quality data are presented on figures 3–6.
