APPENDIX D

Hydrographs for Piezometers at Habitat Monitoring Sites

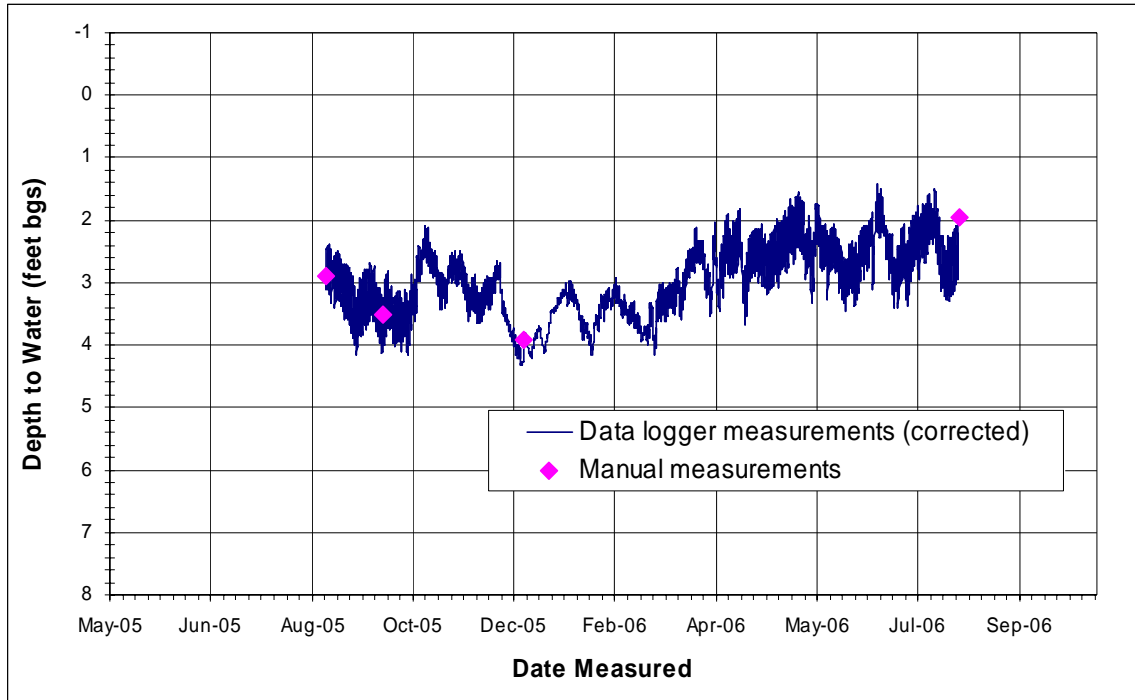
Figure D1. Hydrograph for piezometer at Blankenship Bend.

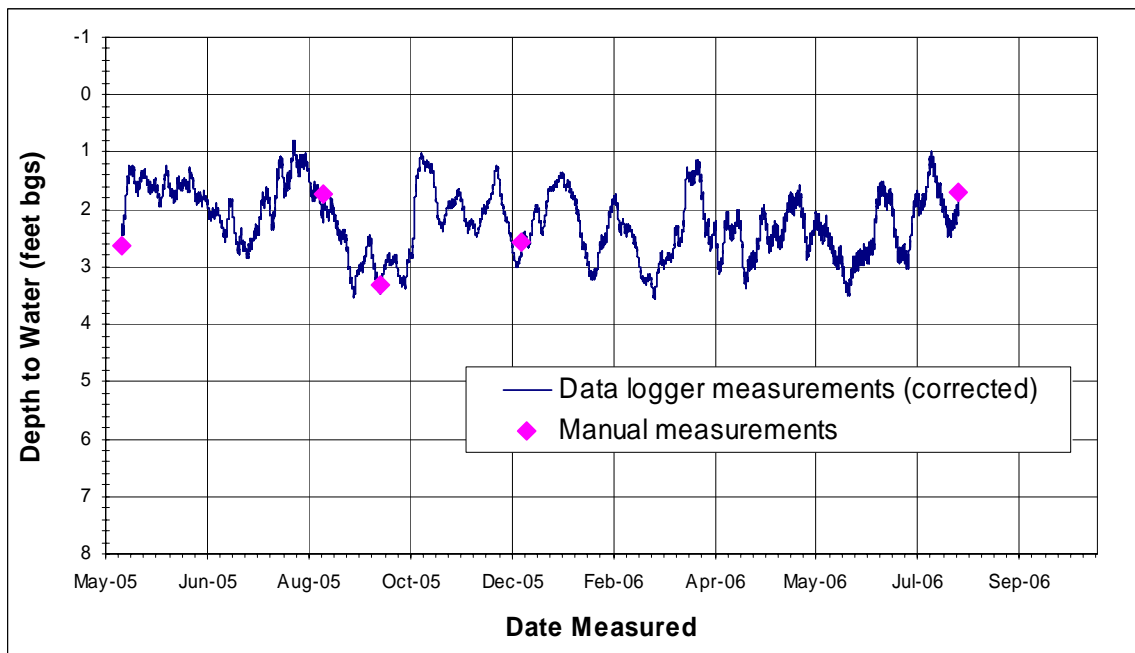
Figure D2. Hydrograph for piezometer at Havasu NE.

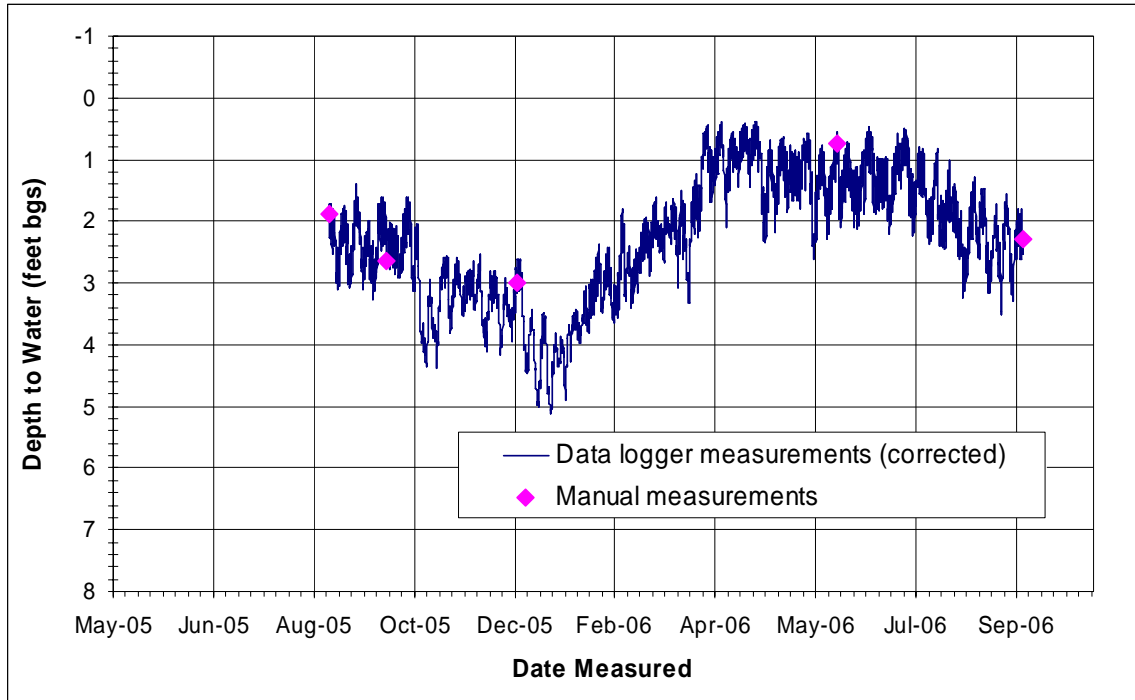
Figure D3. Hydrograph for piezometer at Ehrenberg.

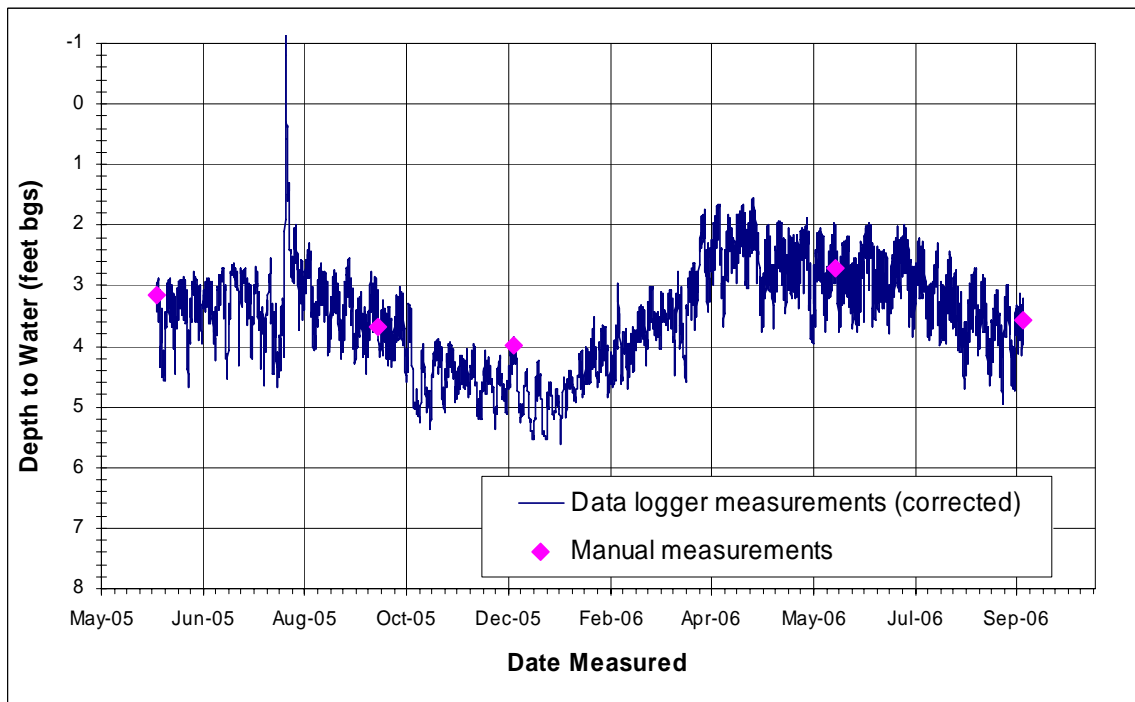
Figure D4. Hydrograph for piezometer at Three Fingers Lake.

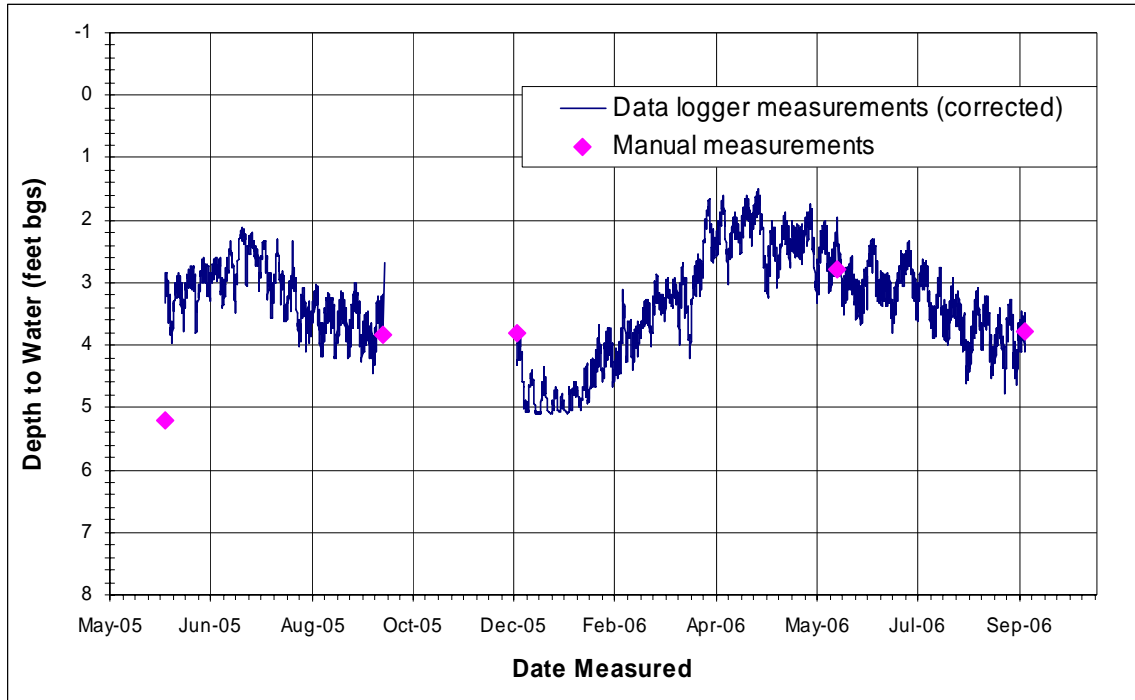
Figure D5. Hydrograph for piezometer at Cibola Lake.

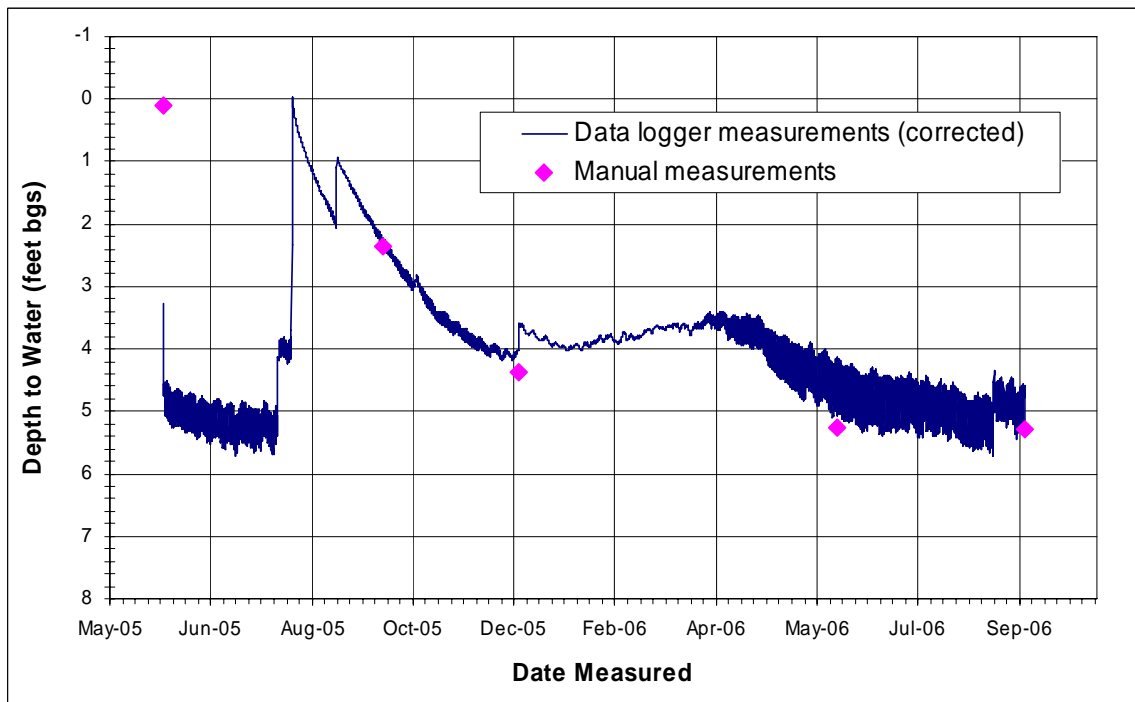
Figure D6. Hydrograph for piezometer at Walker Lake.

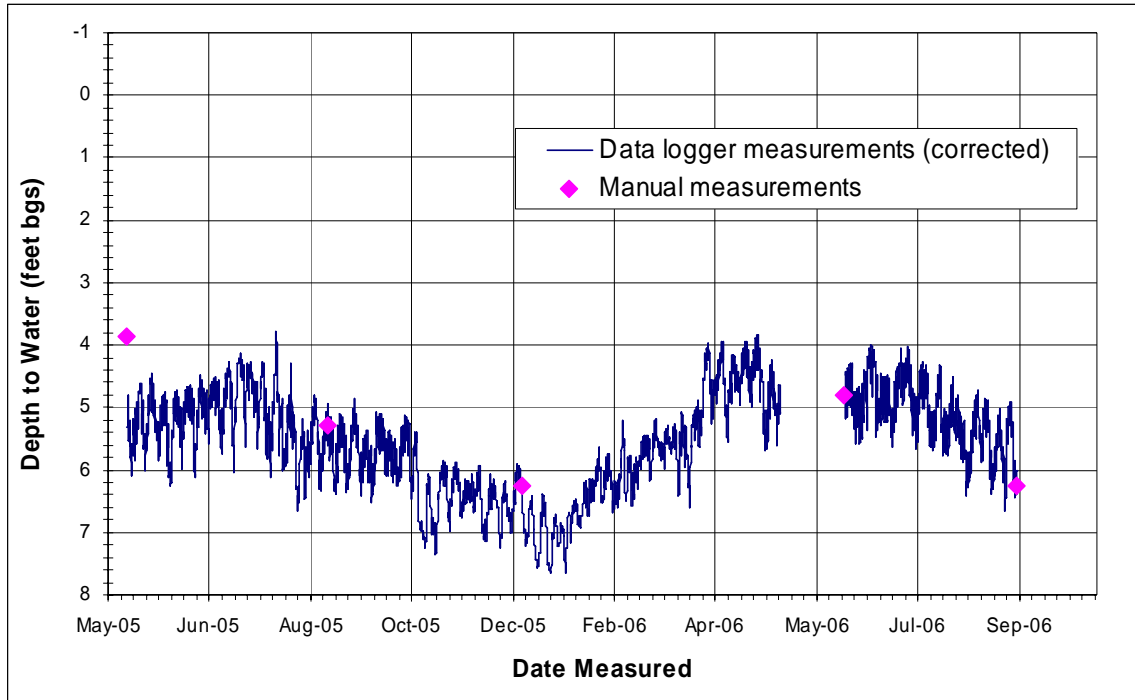
Figure D7. Hydrograph for piezometer at Paradise.

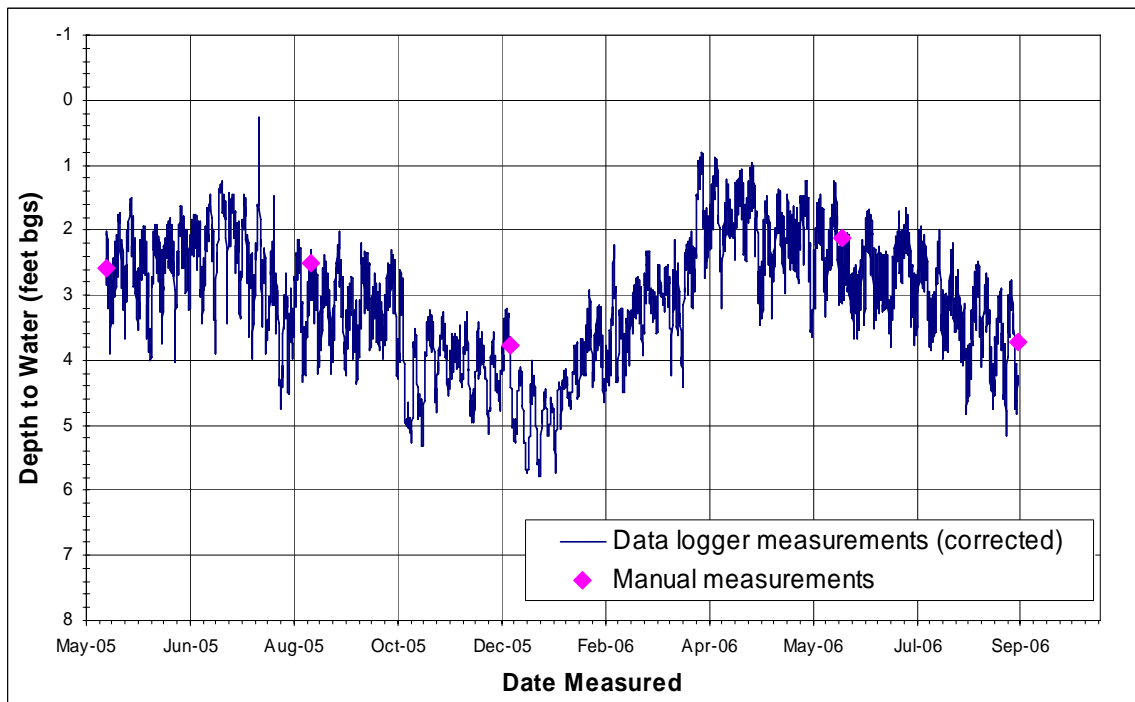
Figure D8. Hydrograph for piezometer at Hoge Ranch.

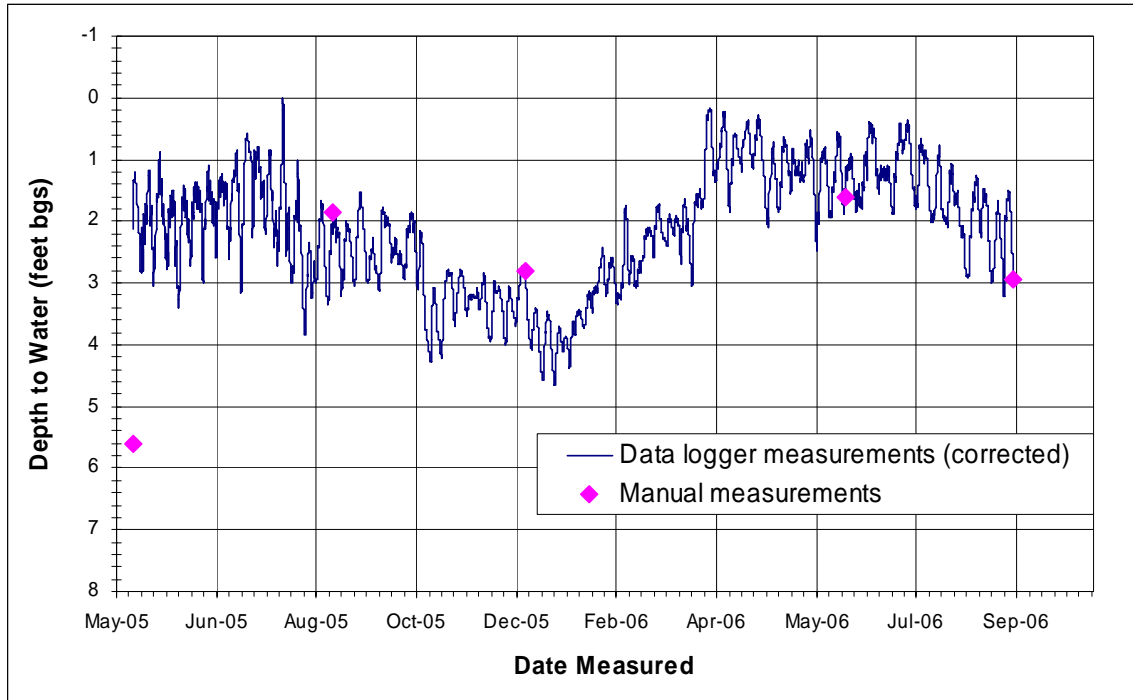
Figure D9. Hydrograph for piezometer at Rattlesnake.

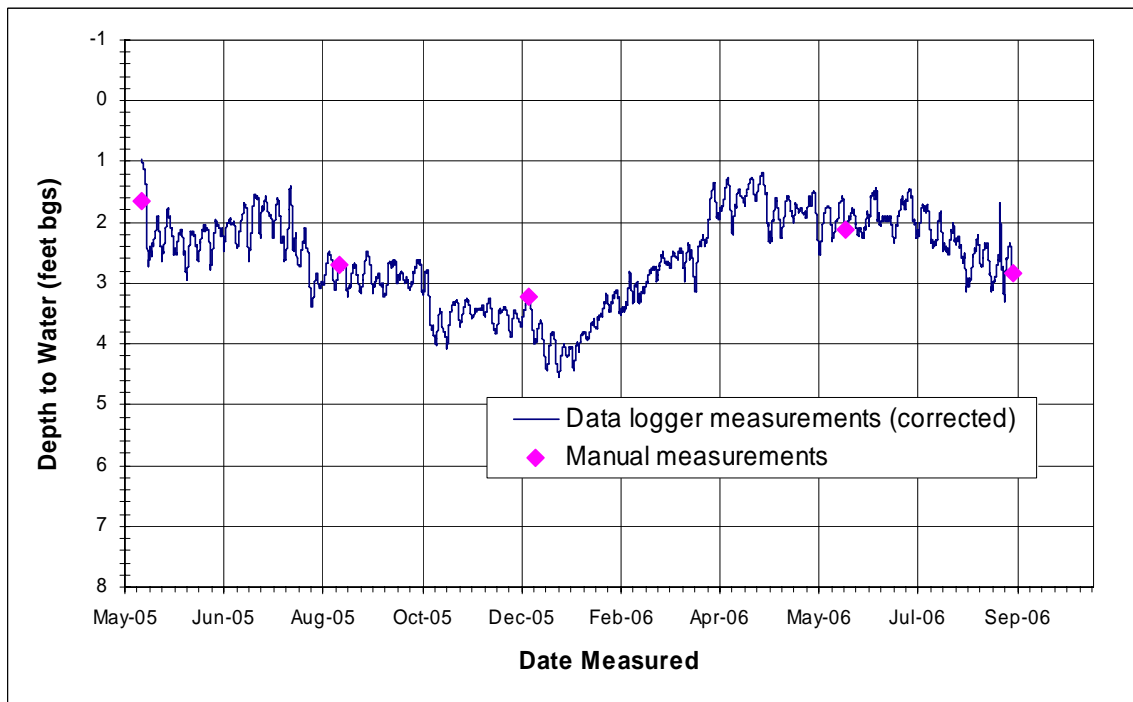
Figure D10. Hydrograph for piezometer at Clear Lake.

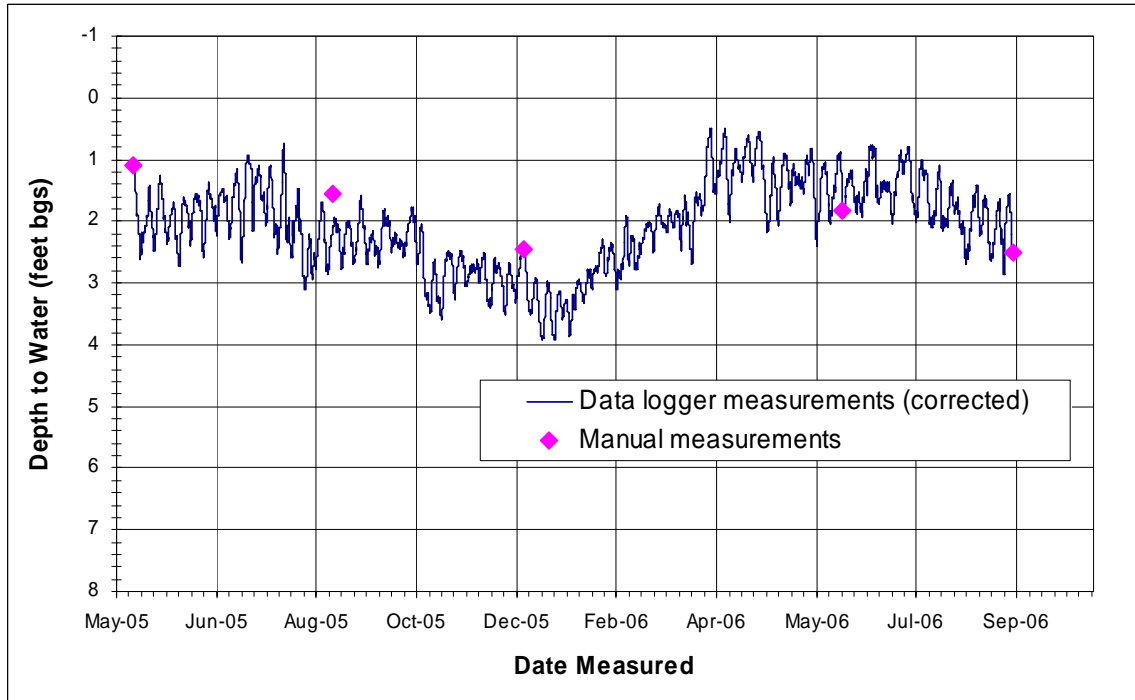
Figure D11. Hydrograph for piezometer at Ferguson Lake.

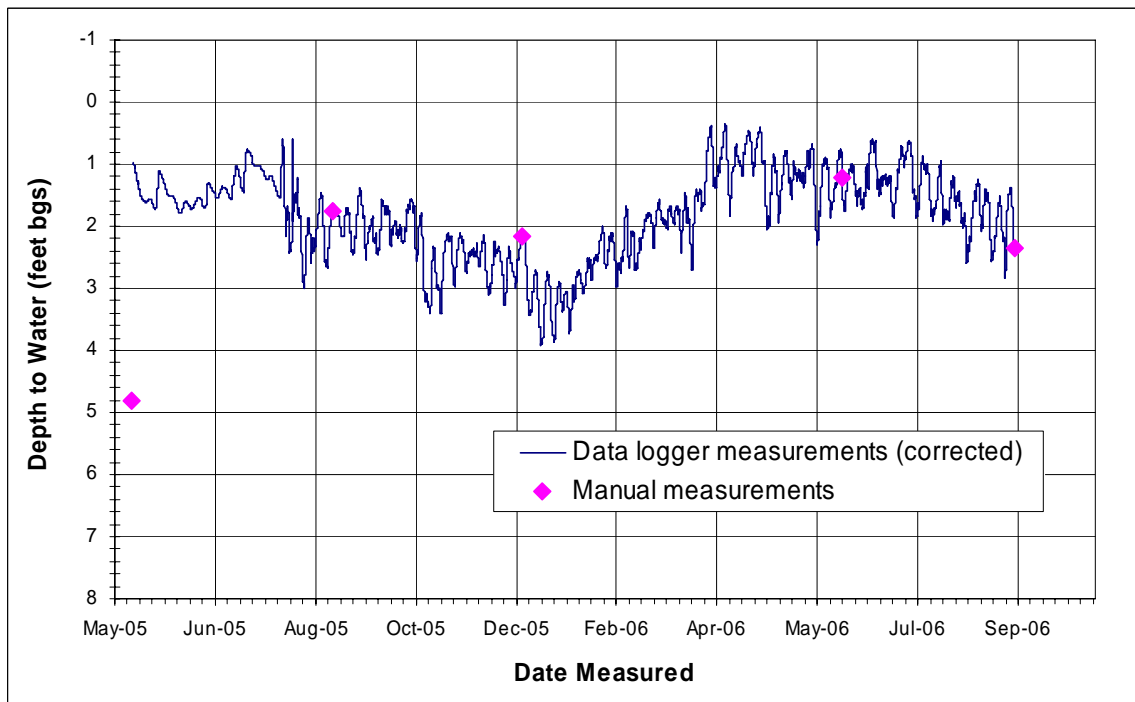
Figure D12. Hydrograph for piezometer at Ferguson Wash.

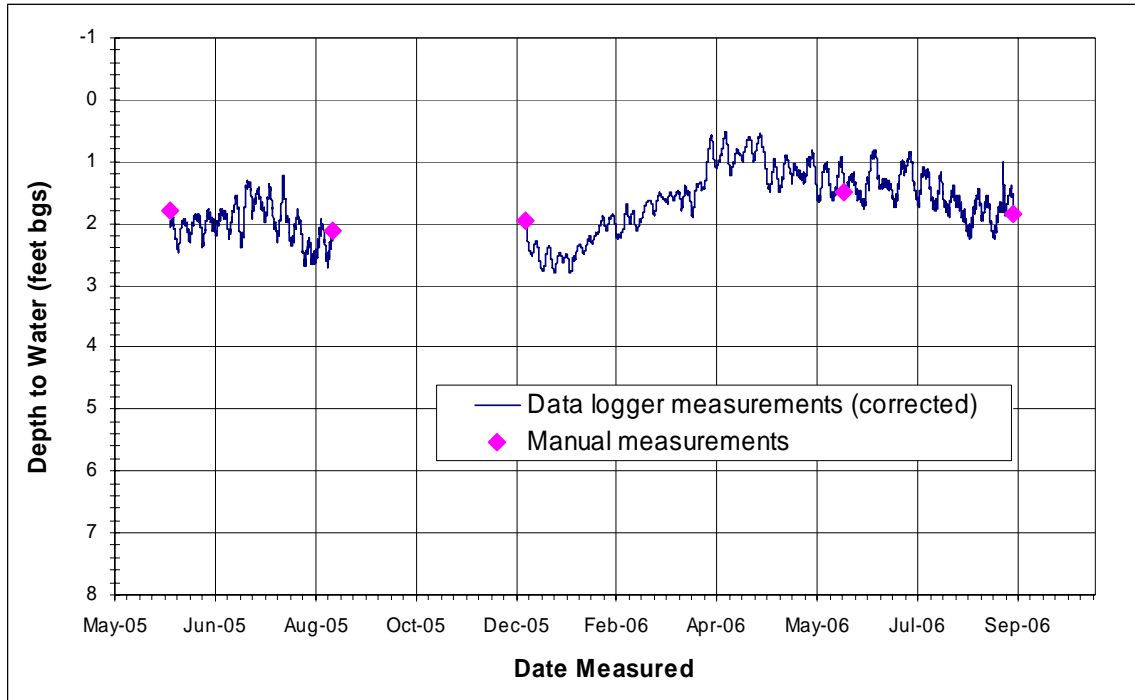
Figure D13. Hydrograph for piezometer at Great Blue Heron.

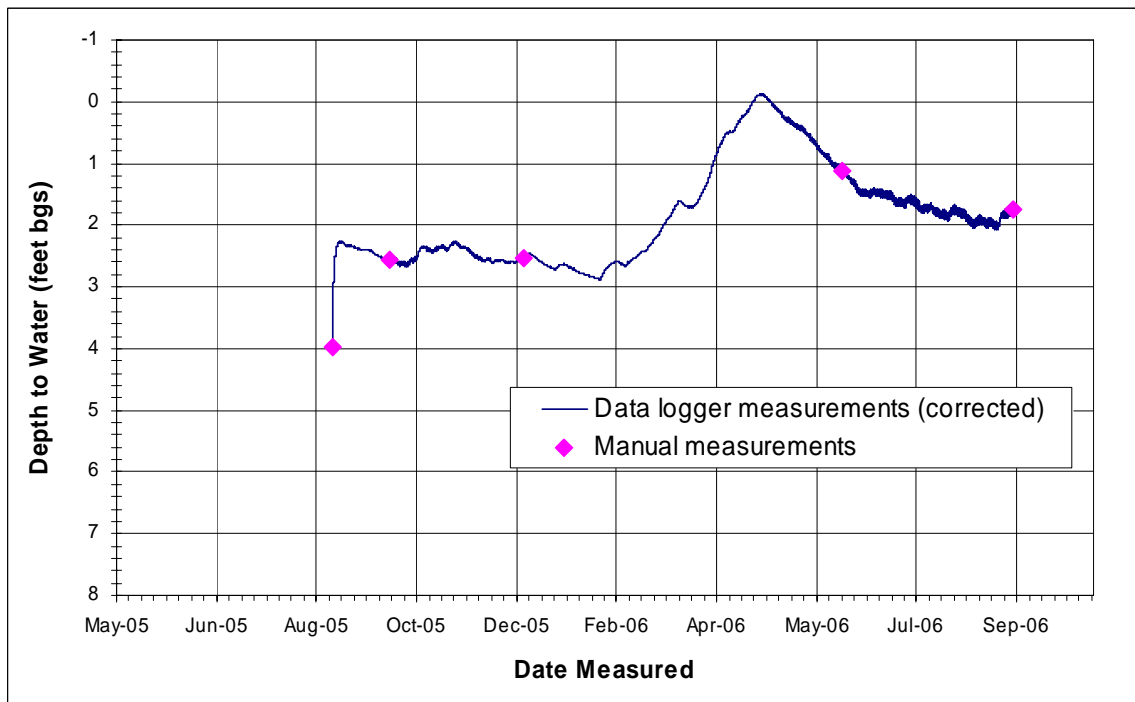
Figure D14. Hydrograph for piezometer at Mittry West.

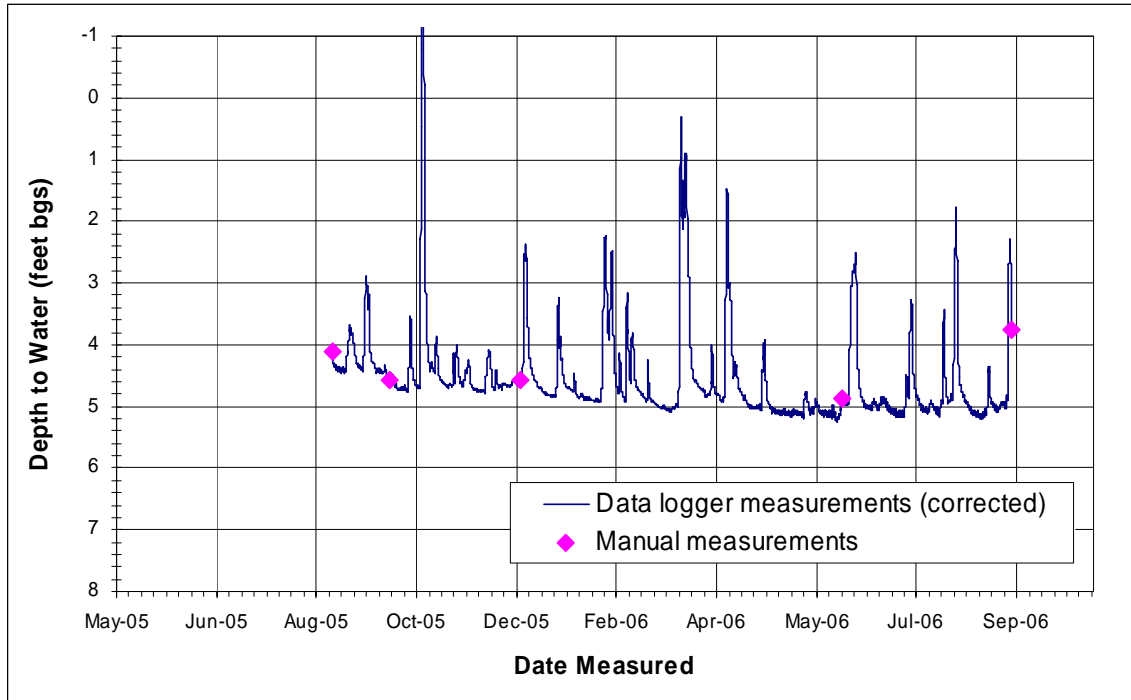
Figure D15. Hydrograph for piezometer at Gila Confluence North.
