Lower Colorado River Multi-Species Conservation Program

Hart Mine Marsh

2015 Annual Report

July 2018

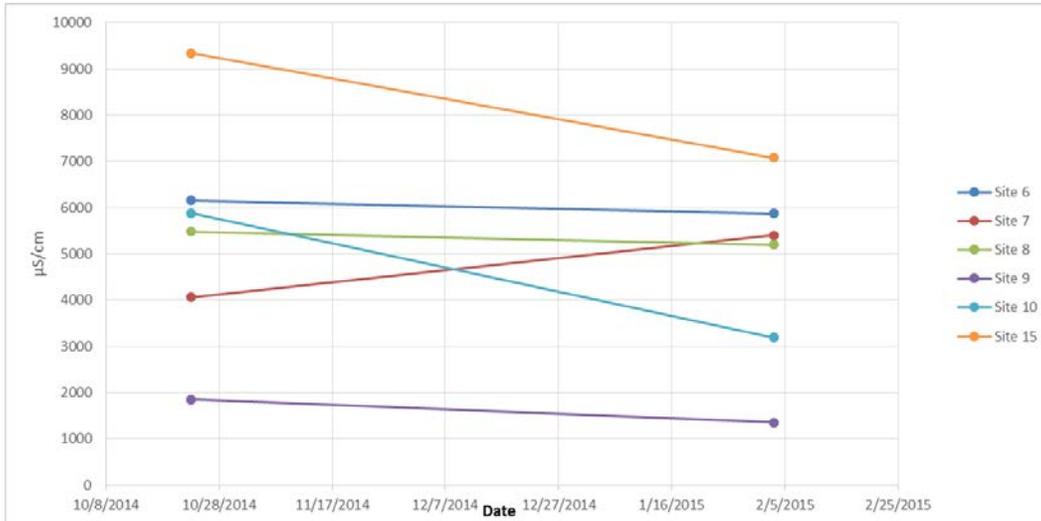
Figure 4.—HMM specific conductivity.

In general, water quality varied from site to site and across seasons. Because very high salinities can affect vegetation and, in turn, impact wildlife species, management activities at this time only targeted specific conductivity. Salinities were effectively controlled by pumping Colorado River water into HMM via Arnett Ditch. Figures 4–6 illustrate the variation in specific conductivity throughout the year at each site when management action (February pumping, flushing, and refilling) has occurred. They also depict the values for dissolved oxygen and pH at each sampling site and show the fluctuations in water quality between these sampling intervals. A complete water quality dataset for the fiscal year is posted internally on the LCR MSCP SharePoint site and is available upon request.

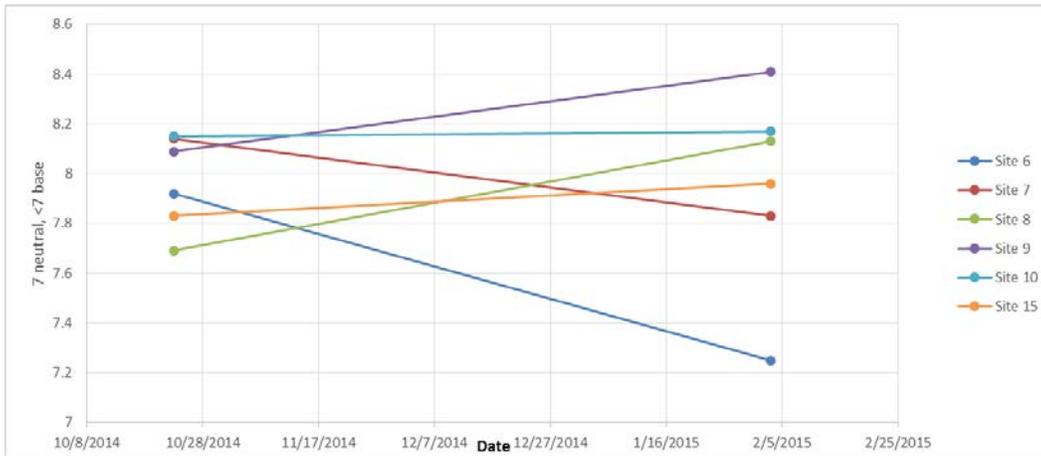
Figure 5.—HMM pH.

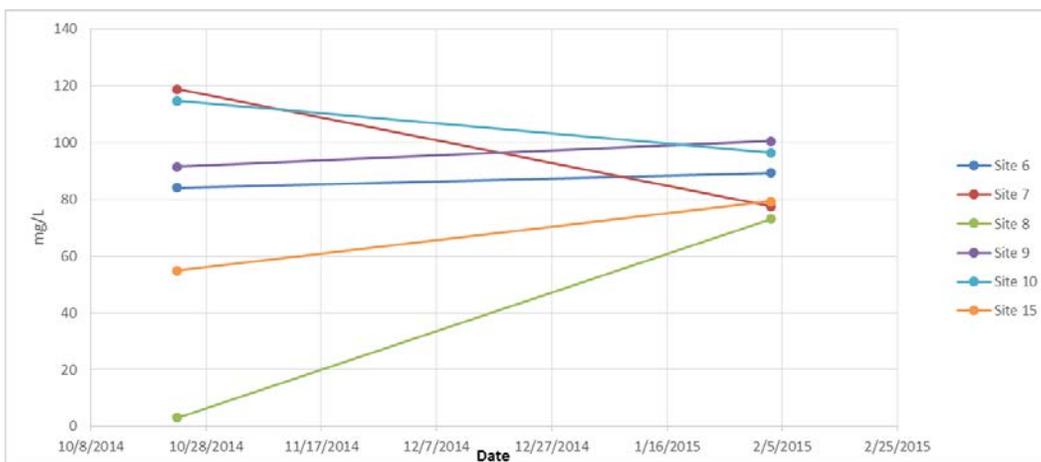
Figure 6.—HMM dissolved oxygen.

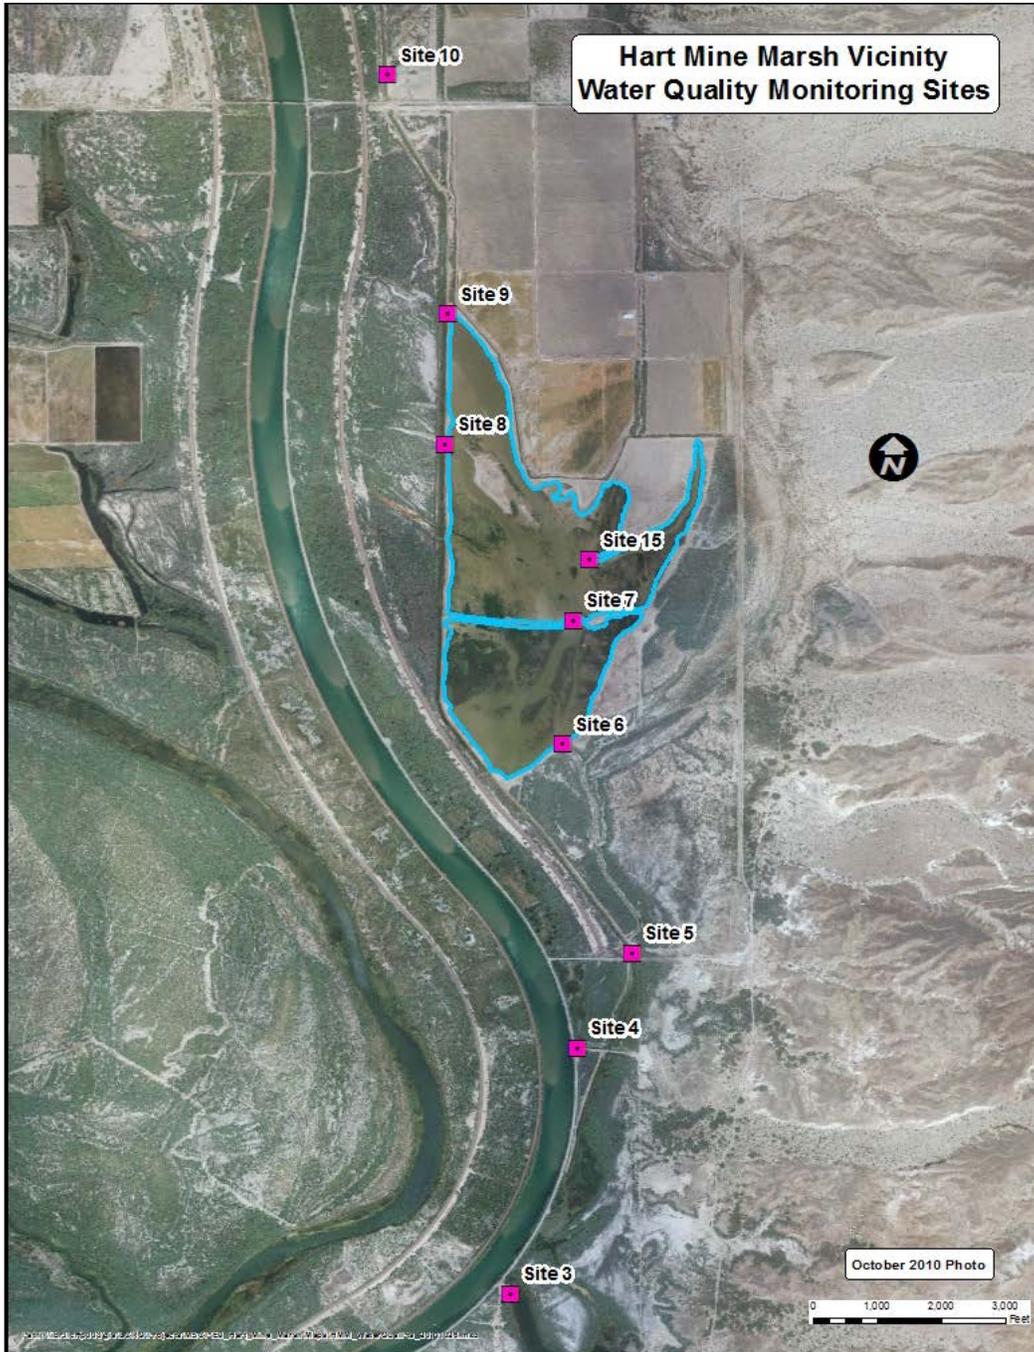
Figure 7.—HMM water quality monitoring locations.

The USFWS is responsible for monitoring and reporting on many abiotic parameters in addition to management of water levels in the marsh throughout the year and during the annual flush. This work is completed through an interagency agreement with Reclamation and typically includes at least four water quality parameters. Water quality parameters, including pH, dissolved oxygen, and specific conductivity (as a measurement of total salinity) were measured throughout the fiscal year. Figure 7 shows the locations (sites) where water quality parameters were measured and collected. Due to staffing and hardware issues, water quality data collection in FY15 was very limited.
