Lower Colorado River Multi-Species Conservation Program

Hart Mine Marsh

2017 Annual Report

October 2018

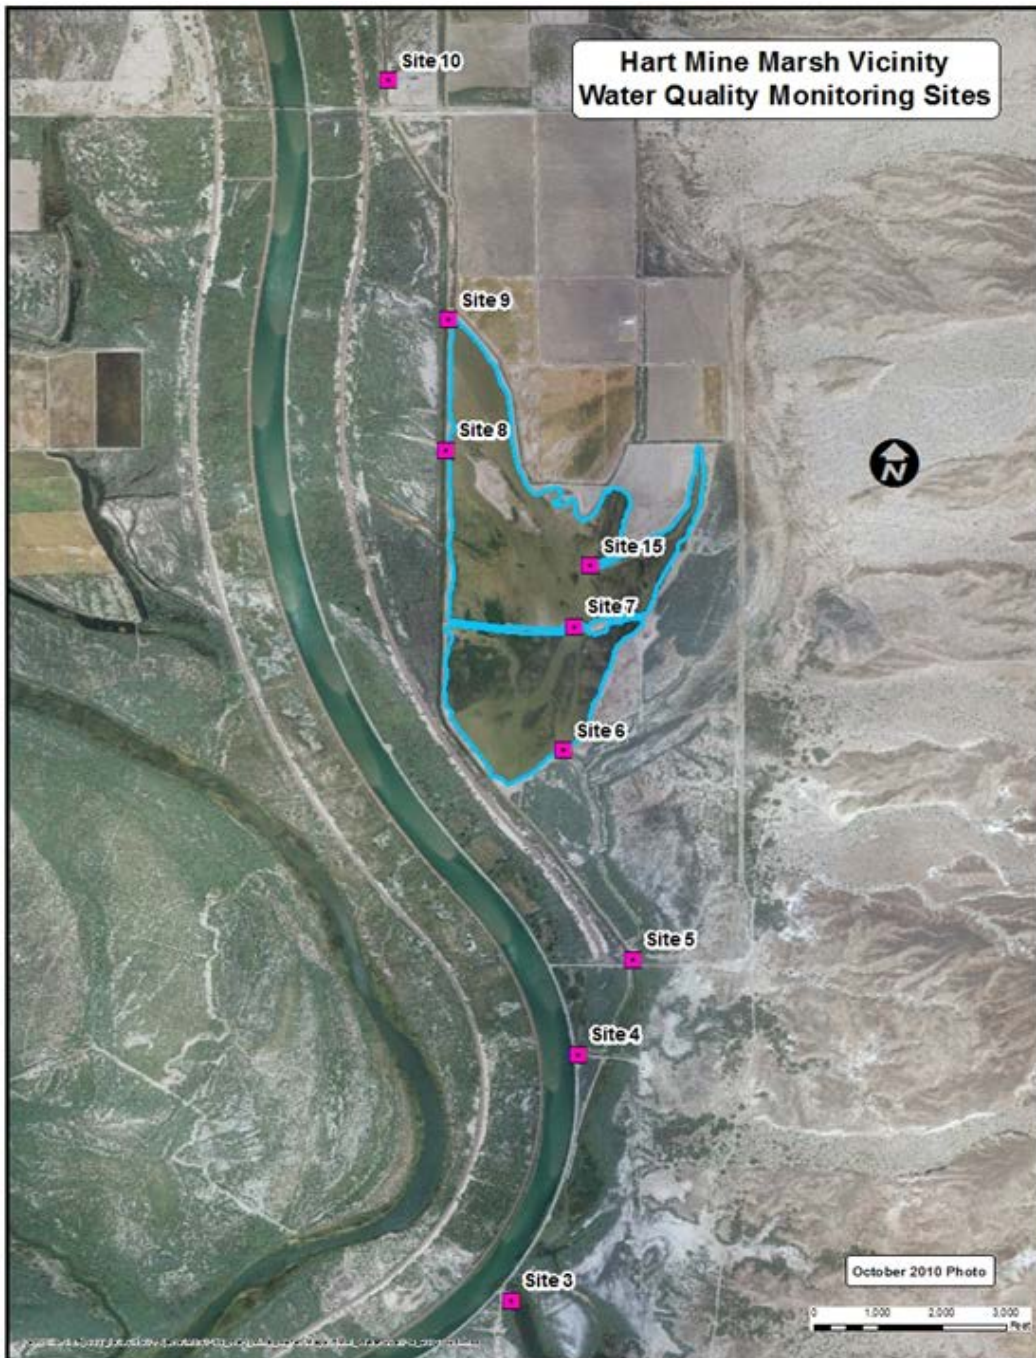
Figure 3.—HMM water quality monitoring locations.

The USFWS is responsible for monitoring and reporting on many abiotic parameters of the site as part of the interagency agreement with Reclamation. The Cibola NWR continued monthly water quality monitoring at specific points throughout the marsh. Water quality parameters including pH, dissolved oxygen, and specific conductivity (as a measurement of total salinity) were measured throughout the fiscal year. Figure 3 shows the locations (sites) where water quality parameters are measured and collected.

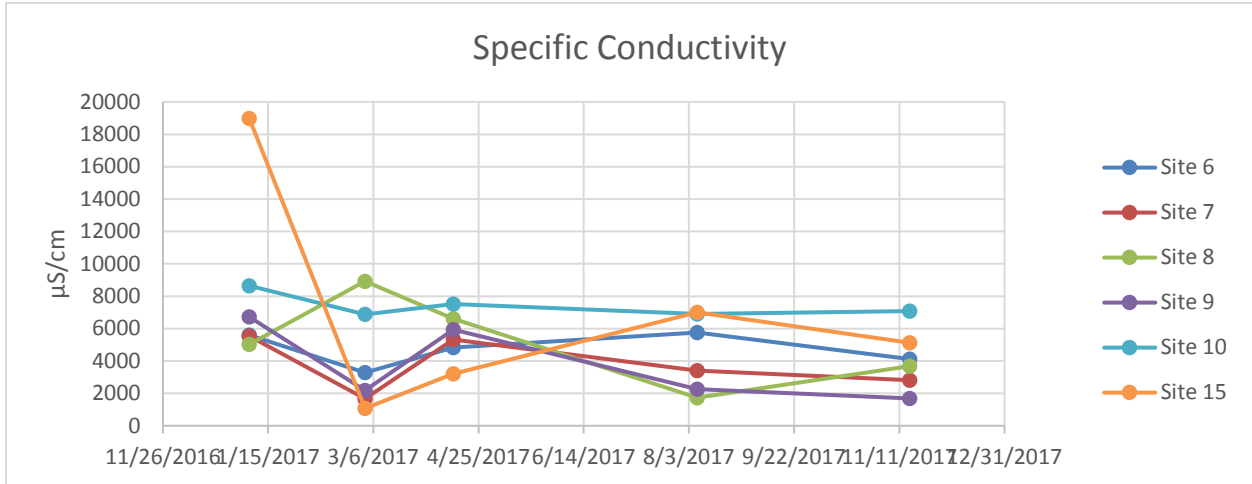
Figure 4.—HMM specific conductivity in microsiemens per centimeter (µS/cm), FY17.

In general, water quality varied from site to site and across seasons. Because very high salinities can affect vegetation, and, in turn, impact wildlife species, management activities at this time only targeted specific conductivity. Salinities were effectively controlled by pumping Colorado River water into HMM via Arnett Ditch. Figures 4–6 illustrate the variation in specific conductivity throughout the year and show the drop in salinities at each site when management action (February pumping, flushing, and refilling) has occurred. They also depict the values for dissolved oxygen and pH at each sampling site and show the fluctuations in water quality between these sampling intervals. A complete water quality dataset for the fiscal year is posted internally on the LCR MSCP SharePoint site and is available upon request.

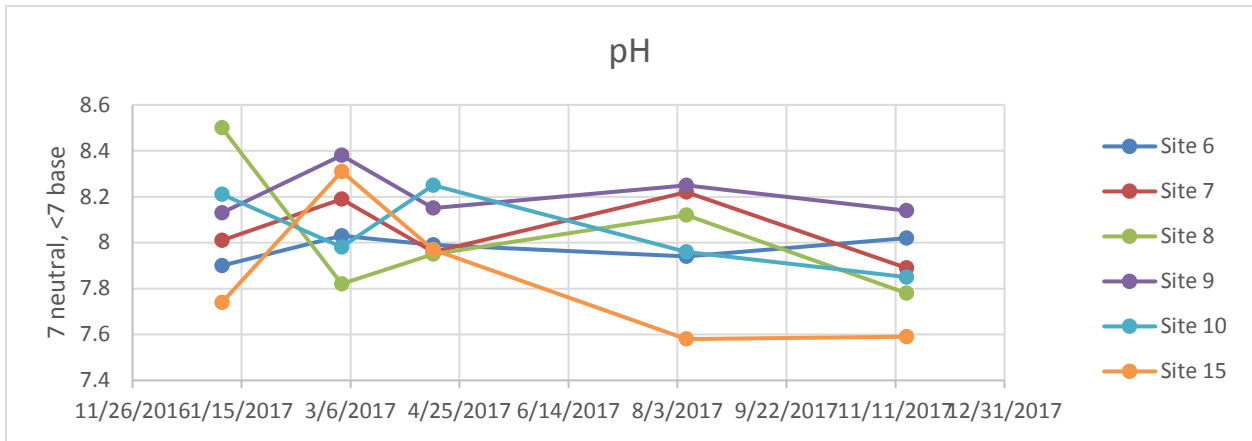
Figure 5.—HMM pH, FY17.

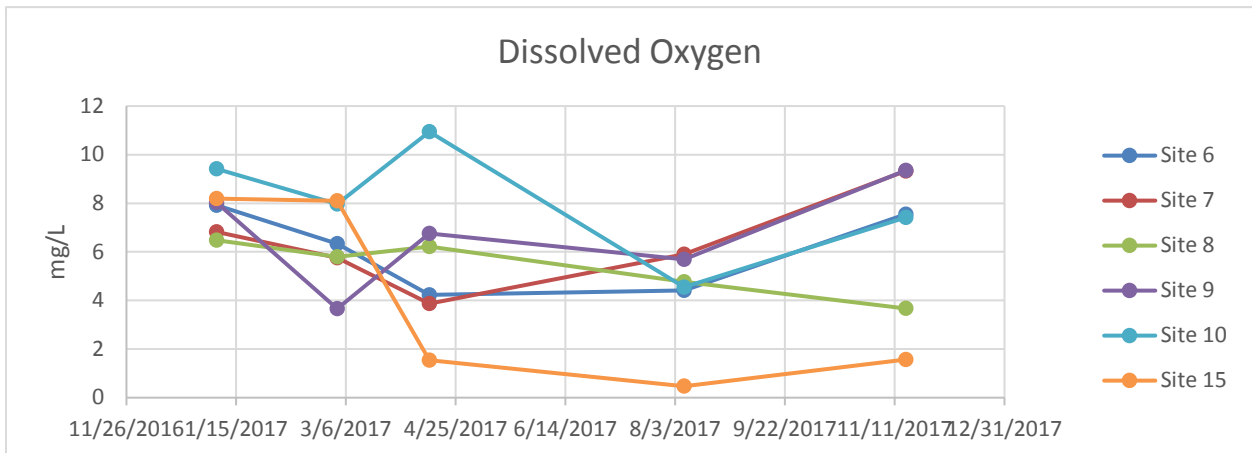
Figure 6.—HMM dissolved oxygen in milligrams per liter (mg/L), FY17.
